## 2017-05-03\_13-42-47-LE-Report-Leak Survey @ SONOTEC

2017-05-03

<b>Folder</b>	<b>Leak Survey @ SONOTEC</b>
<b>Number of Leaks</b>	<b>6 (6 rated)</b>
<b>First measurement</b>	<b>2016-11-18 16:09:38</b>
<b>Last Measurement</b>	<b>2016-11-18 16:22:32</b>
<b>Total leak flow</b>	<b>40.4 l/min</b>
<b>To repair</b>	<b>6</b>
<b>Repaired</b>	<b>2</b>

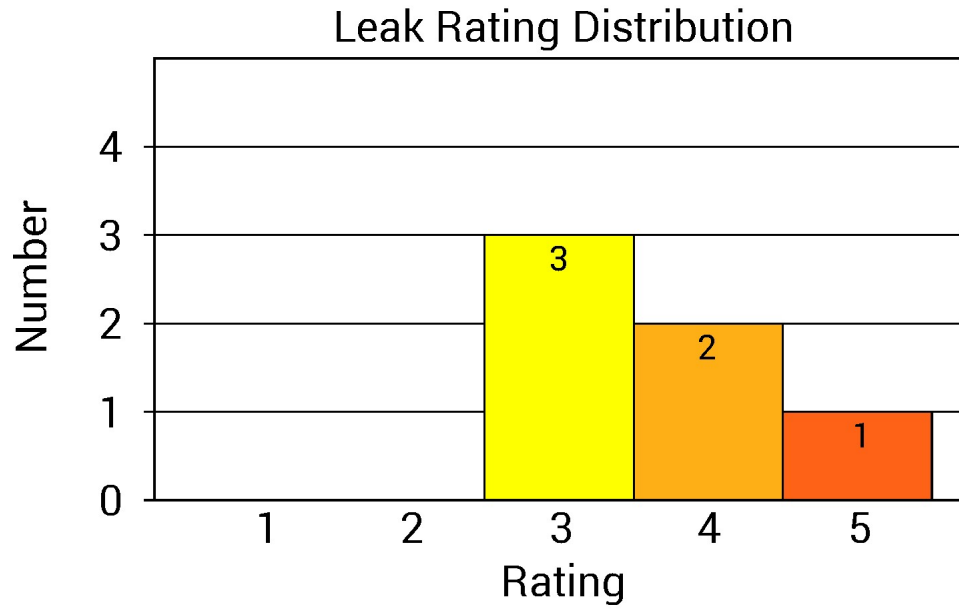
Rating	Id	Flow (l/min)	Level (dB)	Pressure (bar)	Building	Area	Facility	Component	Gas	Priority	To repair	Repaired	Repairer	Repair Date
5	10047-001	11.1	79	8.1	house 4	compressor room	oil filter	sealing	Air	high	yes	no		
	Description: hemp sealing at screw connection										repair note::			
		IMG_0001.JPG		IMG_0002.JPG
